# 5 Performance of Buildings in Houston's Central Business District

*Although Hurricane Ike's winds were not as high as the current design wind speed, some buildings received extensive exterior envelope damage.*

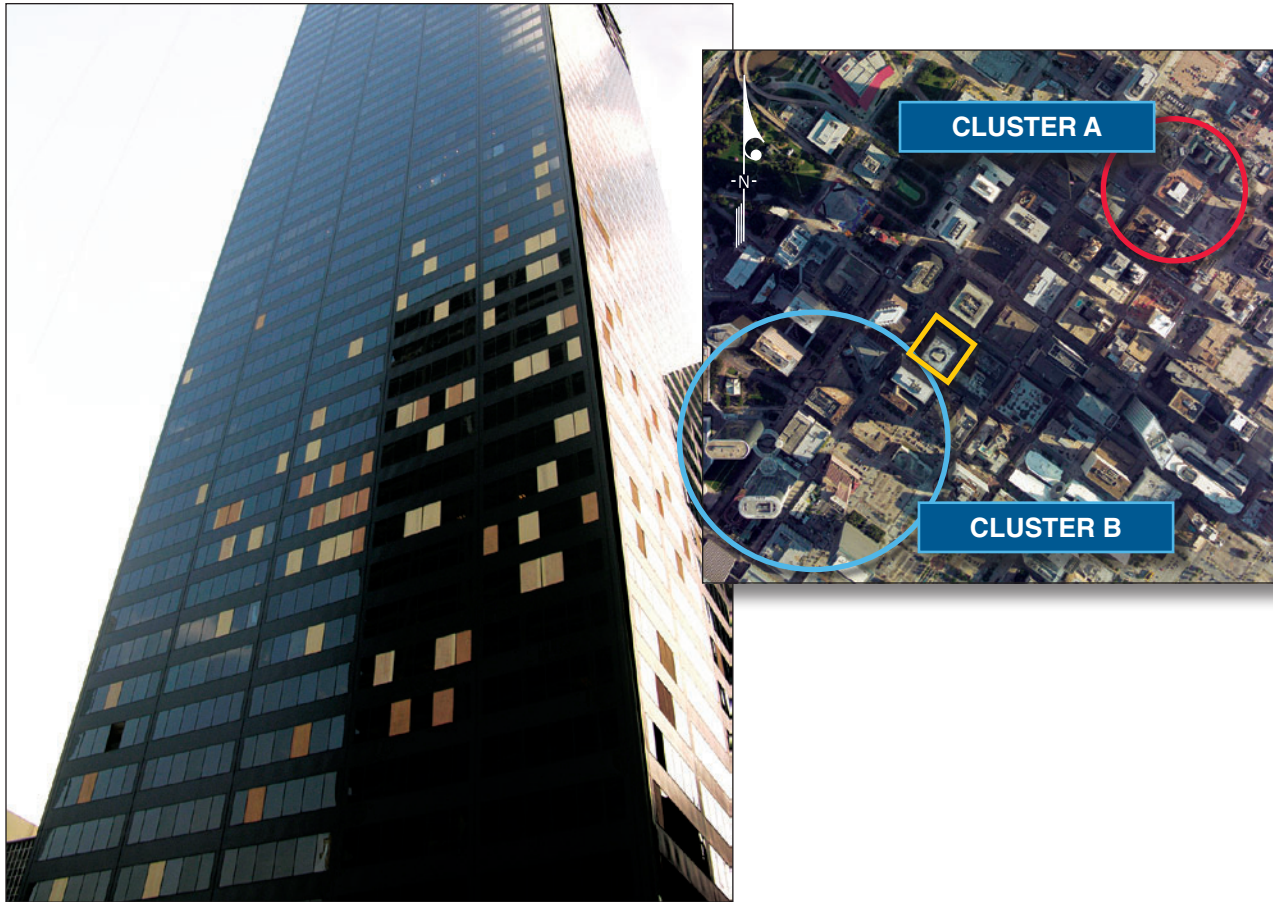
Several of the buildings outside of the clusters had limited glazing damage, ranging from one or a few broken windows to several broken windows as shown in Figure 5-2. At the building shown

**Figure 5-2.**  
Building with glazing damage; location shown by yellow square in inset

in Figure 5-2, 79 windows on one face were boarded up (presumably both the inner and outer panes were broken). For at least five other windows, the outer pane was also broken on this façade (these windows were not boarded).

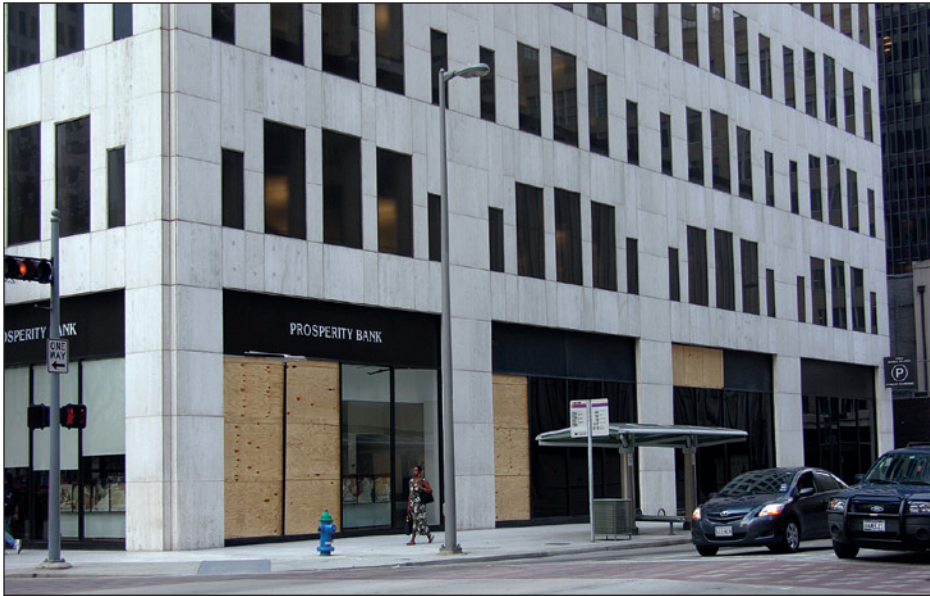
Glazing breakage also occurred several floors above grade at other buildings. There was also random breakage at or near street level at some buildings, as shown in Figure 5-3. Exterior glazing is very susceptible to windborne debris breakage unless it is impact resistant (via use of laminated glass or shutters). Since Houston is not in a windborne debris region, protected glazing is not commonplace. The probability that any one window will be struck by windborne debris is typically small (unless the glazing is downstream from an aggregate-surfaced roof). The probability of impact depends upon local wind characteristics and the amount of natural and manmade windborne debris in the vicinity. The greater the wind speed, the greater the amount of windborne debris that is likely to become airborne. Glazing can also be broken by overpressurization via either high negative or positive wind loads, but this damage is not as common as debris-induced damage. Older glazing is more susceptible to wind-load damage because it is often weakened by scratches. In addition, much of the older glazing on low-rise buildings was installed when little attention was given to wind resistance.

Figure 5-3.  
Random breakage of first  
floor glazing

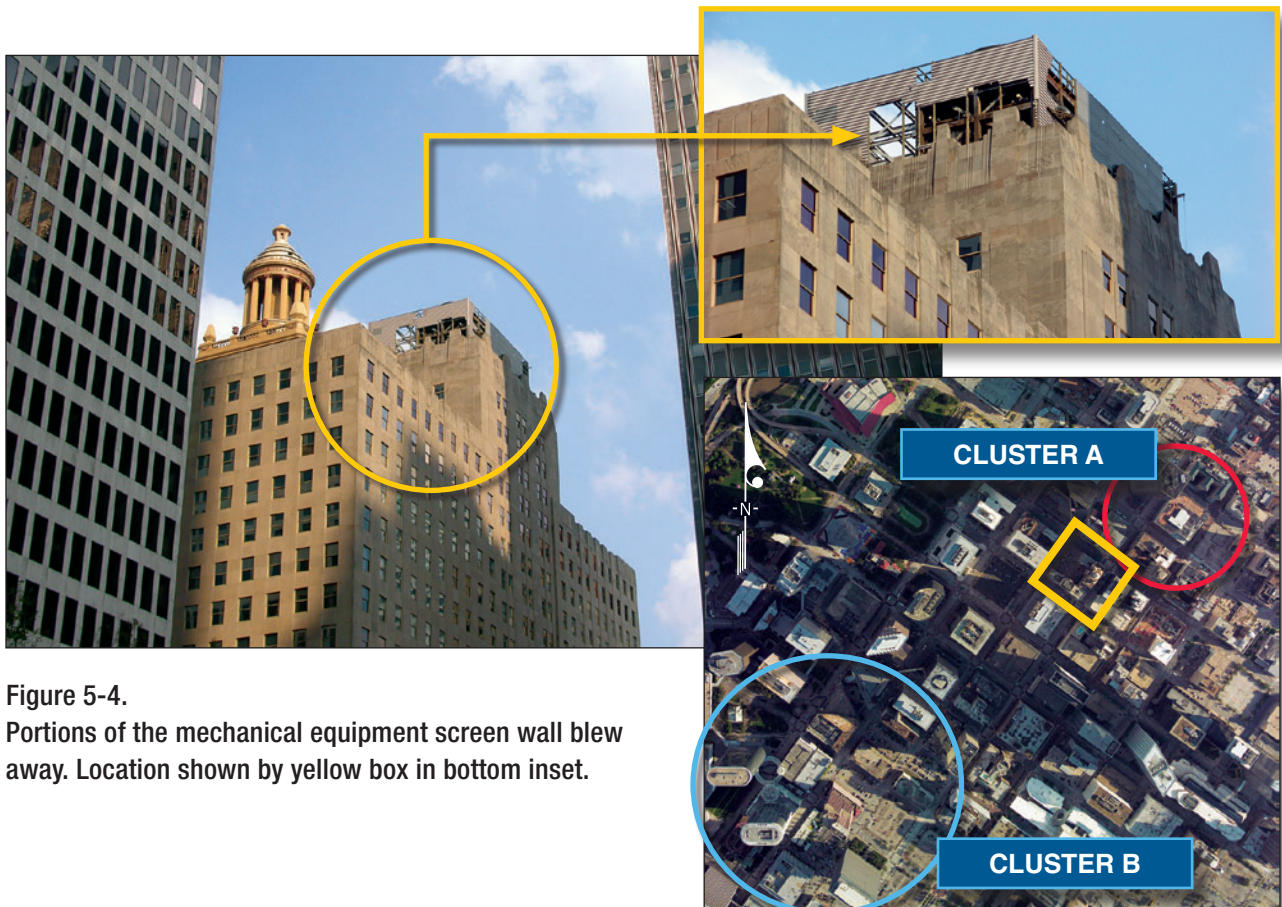
Figure 5-4.  
Portions of the mechanical equipment screen wall blew away. Location shown by yellow box in bottom inset.

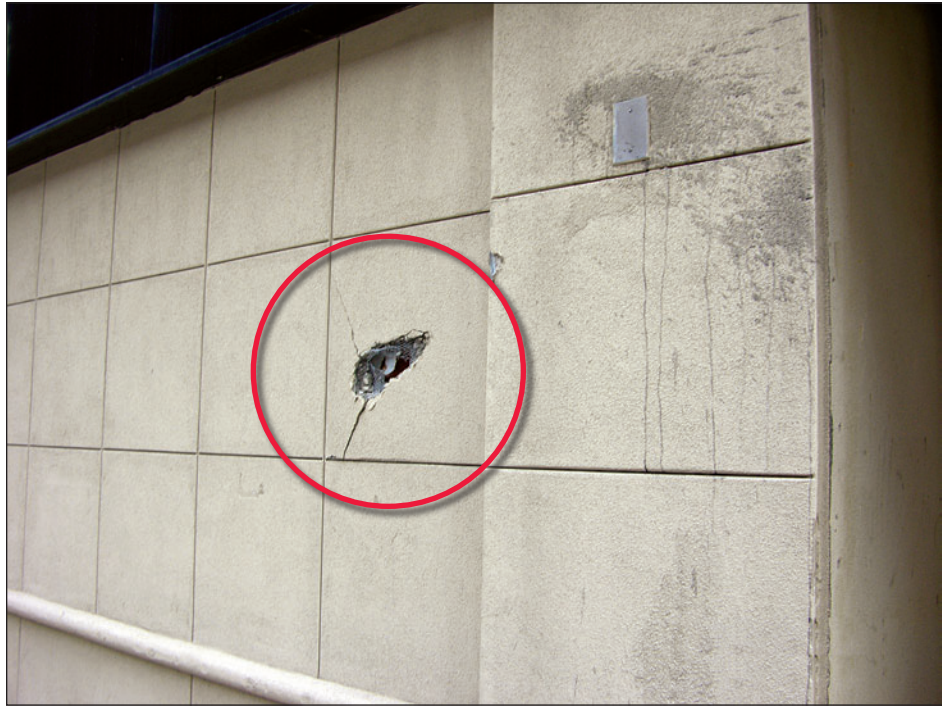
Figure 5-5.  
The wire mesh of this stucco wall was penetrated by windborne debris. The impact location is about 5 feet above the sidewalk.

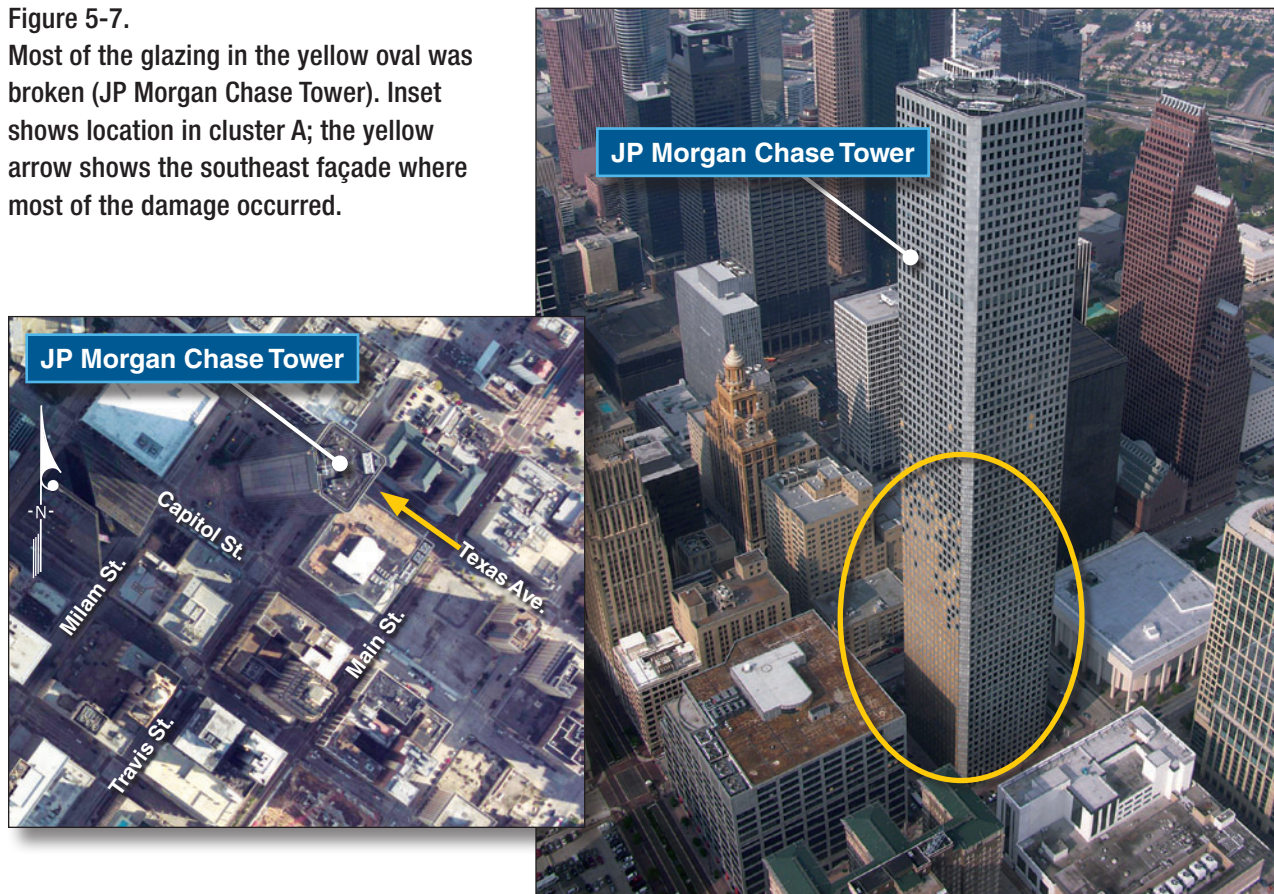
Figure 5-7.

The glazing panes of the JP Morgan Chase Tower are ¼-inch thick each, inner and outer, with a ½-inch air space between the panes. The glazing units are tinted and annealed. There was significant damage on the southeast façade, which was on the leeward side of the building during the time of the strongest winds (yellow circled area in Figure 5-7 and yellow arrow in inset), where both the inner and outer panes of approximately 463 windows were broken. On that façade, all windows in the first 22 floors were broken. The highest broken window was on the 47th floor. The southwest façade had 23 windows with broken inner and outer panes, and the northeast façade had two. The temporary protection and glazing replacement costs were significant.

For most of the southeast façade, very little wind and rain was driven into the offices. However, because of localized wind effects, some offices had significant amounts of rain and wind infiltration, which blew out ceiling boards and toppled office partitions. The MAT was advised that some furniture blew out of offices in this building and landed on the roof of the JP Morgan Chase Center across Travis Street. Because few of the broken windows were on windward façades, there was relatively little interior damage (Note: an explanation of the observed damage pattern is provided later in this section).

Most of the glazing in the yellow oval was broken (JP Morgan Chase Tower). Inset shows location in cluster A; the yellow arrow shows the southeast façade where most of the damage occurred.

Although the glazing damage shown in Figures 5-7 and 5-8 is indicative of damage caused by windborne roof aggregate, the MAT conclusion is that aggregate did not, in fact, cause the damage based on the following observations:

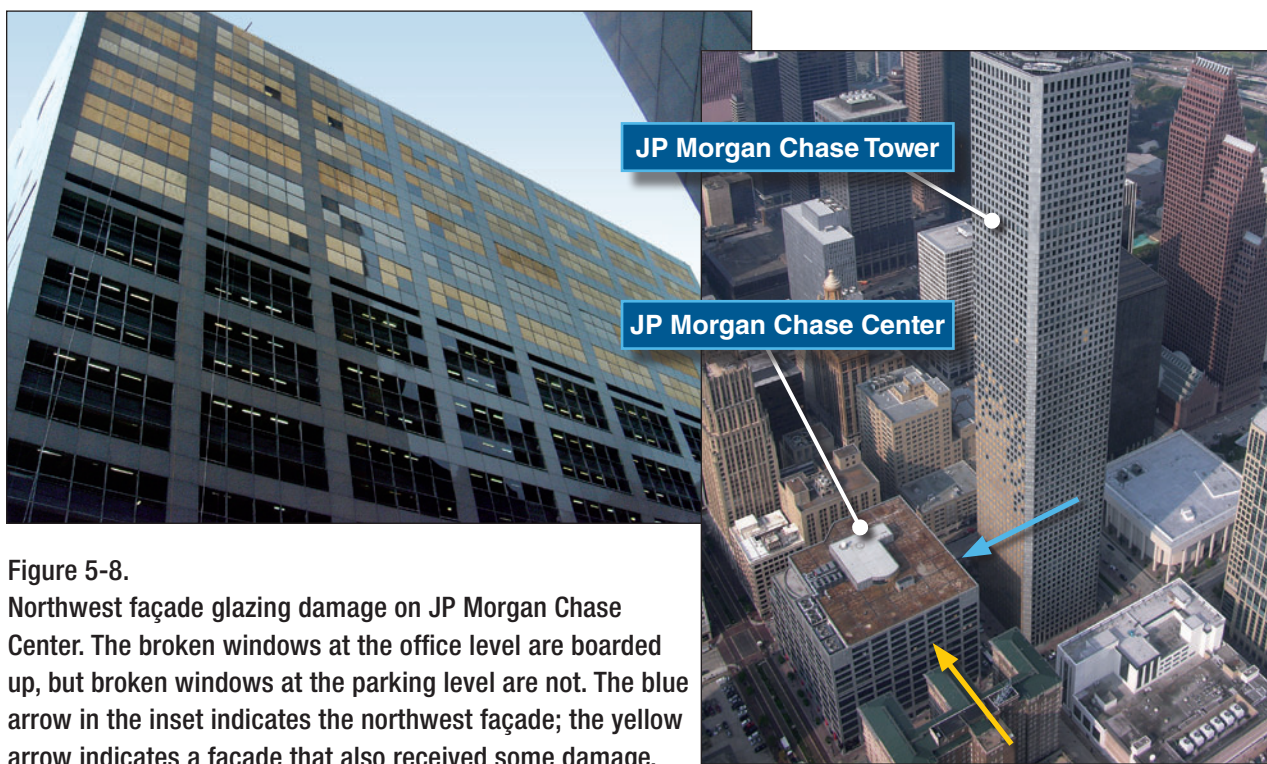
Figure 5-8.

The JP Morgan Chase Center utilizes single-pane, heat-strengthened glazing. Virtually all of the penthouse glazing and the glazing on the northwest façade, which was the windward side of the building during the time of the strongest winds (Figure 5-8), was broken. At least 16 windows were broken on the façade with the yellow arrow in Figure 5-8 inset. Only a few windows were broken in the opposite façade. There was no damage in the southeast façade.

The broken glazing on the northwest façade blew approximately 50 feet into the interior of the building. Once the exterior glazing was breached, wind-driven rain penetrated into the building, causing extensive interior damage.

Northwest façade glazing damage on JP Morgan Chase Center. The broken windows at the office level are boarded up, but broken windows at the parking level are not. The blue arrow in the inset indicates the northwest façade; the yellow arrow indicates a façade that also received some damage.

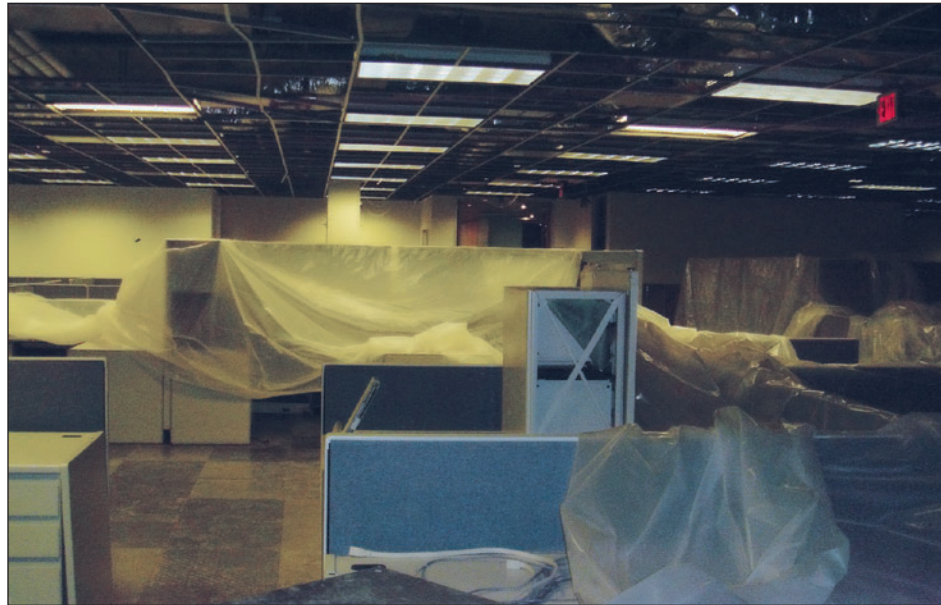
**Figure 5-9.**  
View of repairs to an office  
damaged in the JP Morgan  
Chase Center

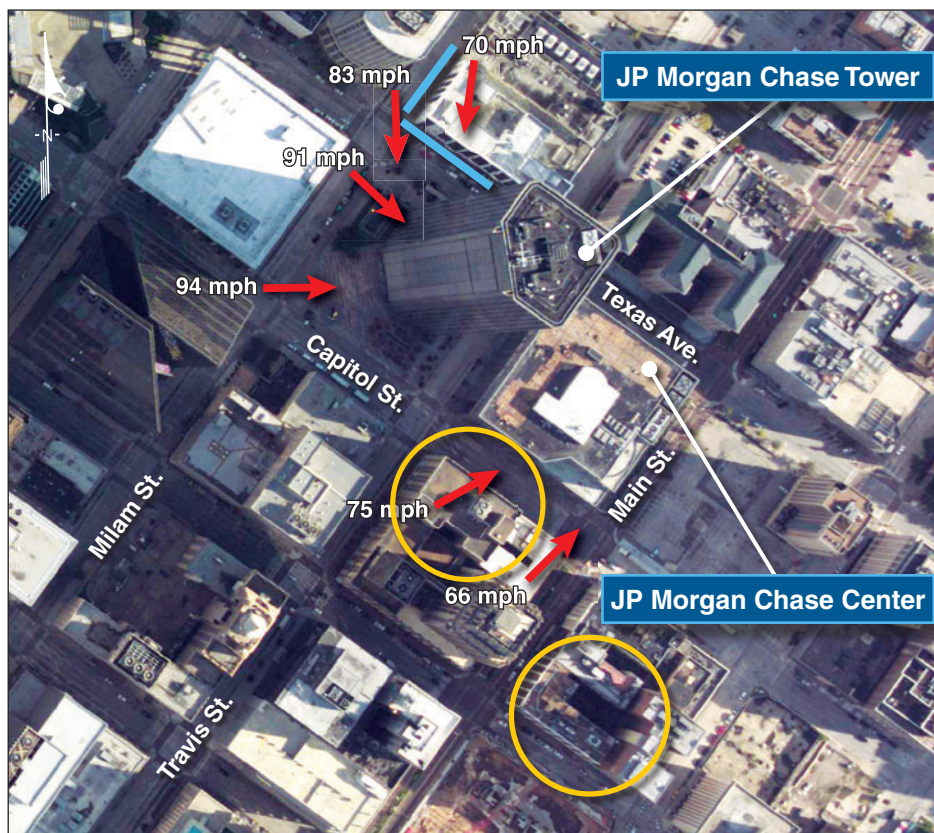
Although aggregate-surfaced BURs were present on the buildings shown in the yellow and orange circles in Figure 5-10, it is unlikely that debris from these roofs caused the glazing damage observed at the JP Morgan Tower and Center. The

The wind direction and relatively low speed precluded aggregate from the roofs in the orange circle from being a debris source. The speed and direction may have been sufficient to cause aggregate to be blown from the penthouse of the building shown in the yellow circle of Figure 5-10 (and discussed in Section 5.2.4), but if that occurred, the aggregate would likely only have struck the JP Morgan Center façade, which had very little damage. MAT observations from a helicopter and the roofs of the Tower and Center did not reveal any other aggregate-surfaced roofs in the vicinity.

Figure 5-10. Locations of possible debris sources that impacted the JP Morgan Tower and Center. Aggregate-surfaced roofs within cluster A area shown by yellow circles. Blue lines show location of failed metal panel veneer. SOURCE: NOAA, SEPTEMBER 17, 2008

The MAT postulates that the glazing damage occurred as a result of the following: some glazing in the Tower or the Center failed, either due to windborne debris or overpressurization, and the resulting glass shards became enveloped in vortices that developed between the two buildings. As the shards impacted the opposing façades, additional shards were injected into the vortices. It is believed that the vortices lifted the shards upwards, thereby causing damage at the upper floors (shown in Figure 5-11). Potential initial debris sources include trees along the sidewalks and metal wall panels from a nearby building (blue lines shown in Figure 5-10; refer also to Section 5.2.4).

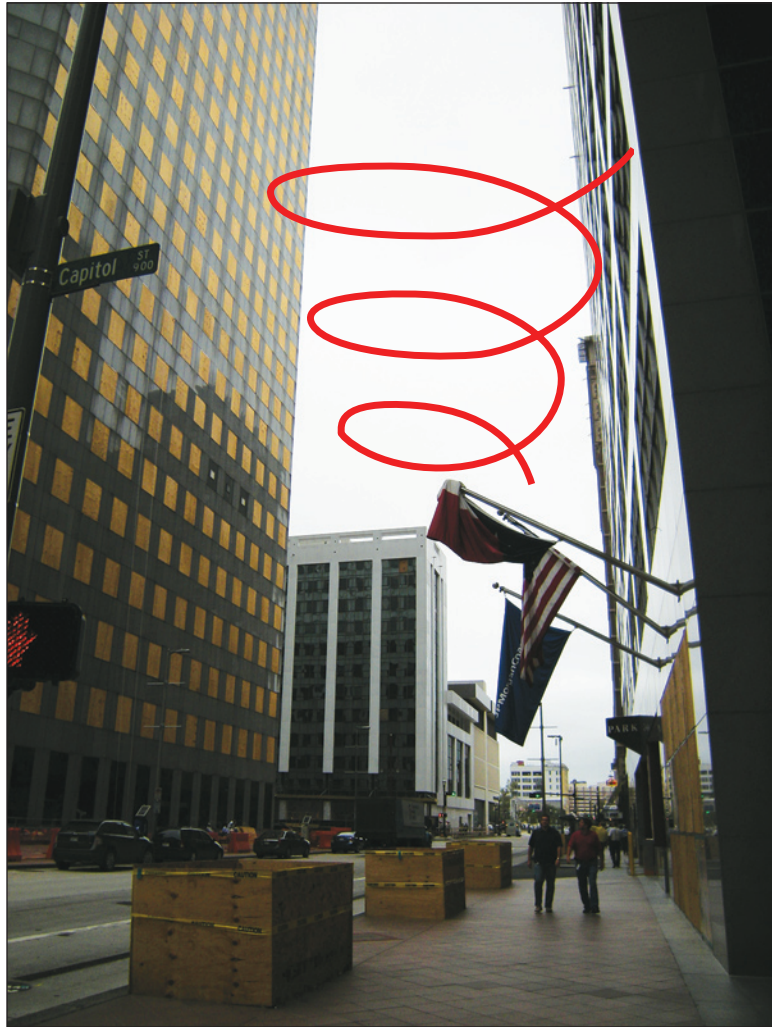
Figure 5-11.

The MAT's postulate is consistent with initial research work on the observed glazing damage conducted by the University of Notre Dame in a paper titled *Saga of Glass Damage in Urban Environments Continues: Consequences of Aerodynamics and Debris Impact During Hurricane Ike* (Kareem, 2008).<sup>2</sup> A model of the JP Morgan Tower and surrounding buildings was constructed and flow visualization experiments were conducted in a wind tunnel. In addition, flow visualization was analyzed by computational fluid dynamics (CFD). The wind tunnel and CFD studies both demonstrated that a series of vortical flow structures formed between the two façades that were heavily damaged (Figure 5-11).

The Tower is on the left and the Center is on the right. It is believed that vortices developed between these façades, and that glass shards entrapped within the vortices were slammed against and broke glazing in the opposing façades.

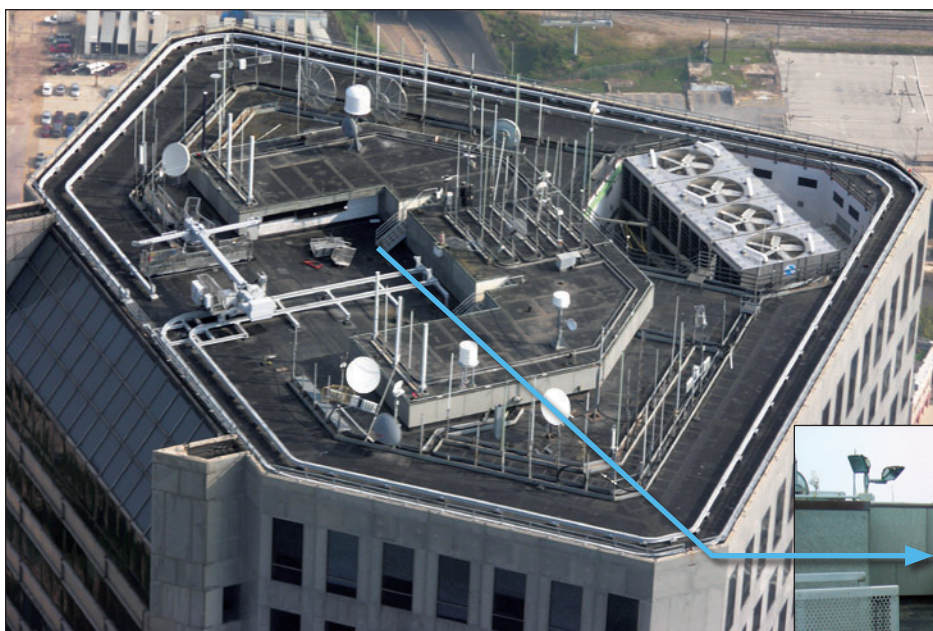
A portion of the window washing equipment on the JP Morgan Chase Tower broke loose and slammed around, damaging the equipment (Figure 5-12 inset).

Figure 5-12.  
View of the JP Morgan  
Chase Tower roof. Inset  
shows damaged window  
washing equipment.

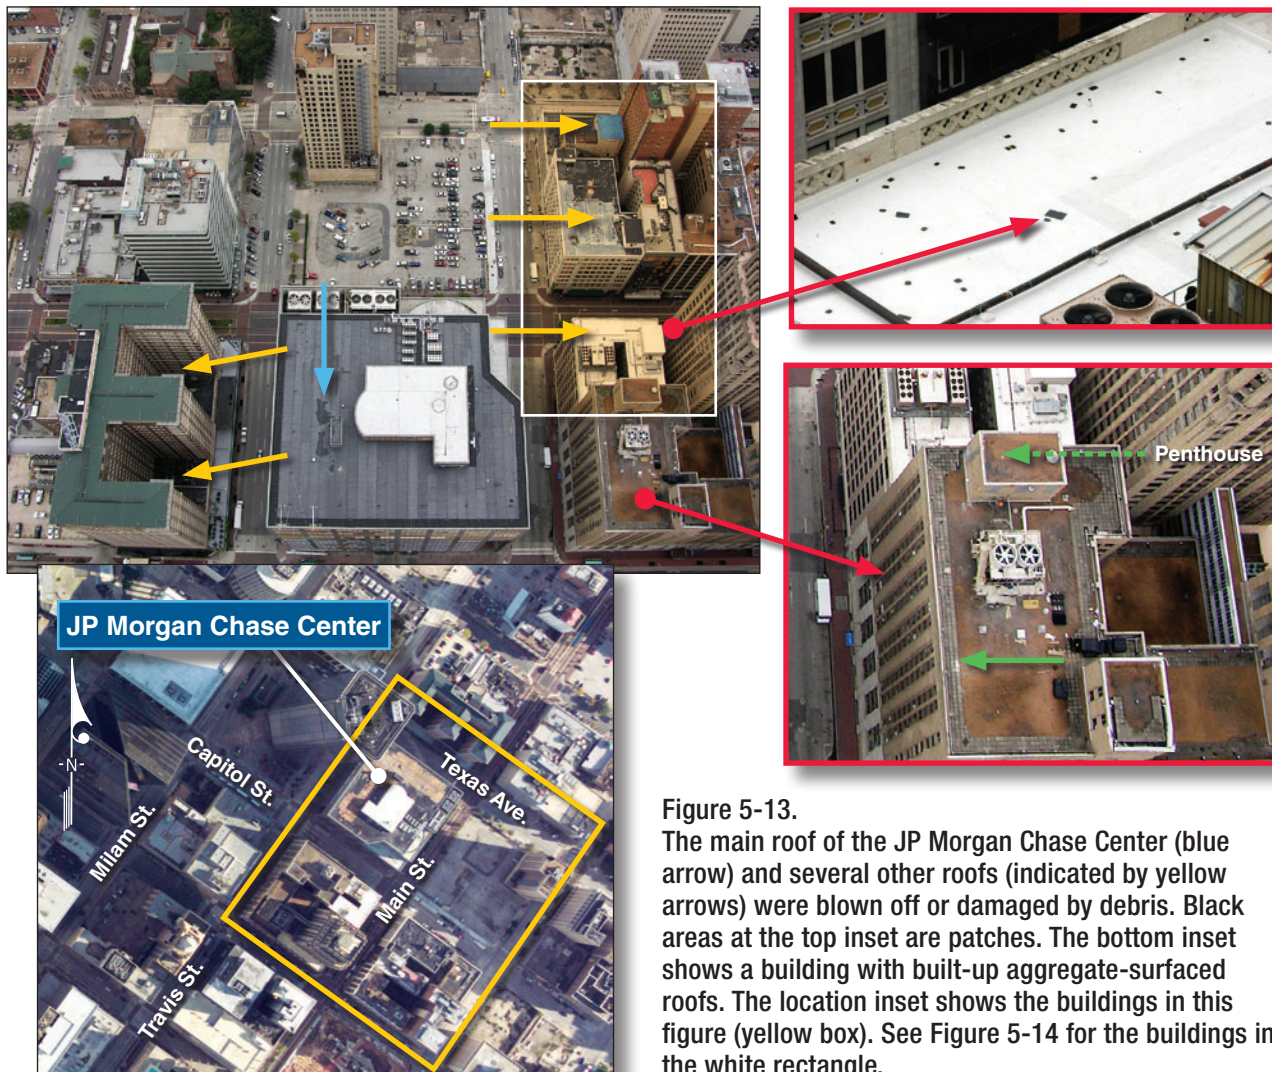
The roofs shown by the yellow arrows in Figure 5-13 had either been blown off (i.e., the tarped roofs) or punctured by windborne debris. Much of the roof puncture and glazing damage was likely caused by windborne glass shards.

At the building shown in the bottom inset at Figure 5-13, concrete pavers had been installed around the perimeter of the main roof (solid green arrow at the inset) and at a portion of one of the penthouses as part of the original roof surfacing. However, the penthouse roof indicated with the dashed green arrow did not have pavers; its roof had a raised curb at the roof edge. Aggregate from this penthouse roof may have struck the side of JP Morgan Chase Center that had very little glazing damage.

Figure 5-13. The main roof of the JP Morgan Chase Center (blue arrow) and several other roofs (indicated by yellow arrows) were blown off or damaged by debris. Black areas at the top inset are patches. The bottom inset shows a building with built-up aggregate-surfaced roofs. The location inset shows the buildings in this figure (yellow box). See Figure 5-14 for the buildings in the white rectangle.

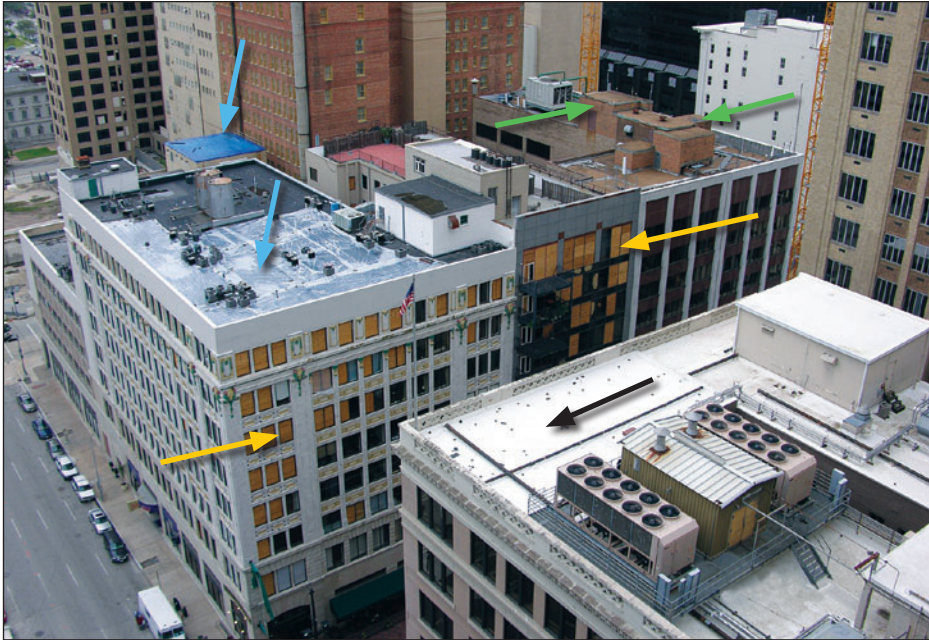
Figure 5-14 is a view of the roofs in the white rectangle at Figure 5-13. Blue and clear plastic tarps cover two roof areas. The green arrows show where an aggregate-surfaced built-up membrane lifted and peeled back. It is doubtful that aggregate from these roofs struck the JP Morgan Chase Tower or Center buildings. The punctured roof with the black arrow is the same as shown at the top inset of Figure 5-13. Several windows were broken in the buildings shown by the yellow arrows.

Figure 5-14.  
Glazing damage (yellow arrows) at two of the buildings shown in the white rectangle in Figure 5-13. The blue, green, and black arrows indicate damaged roofs.

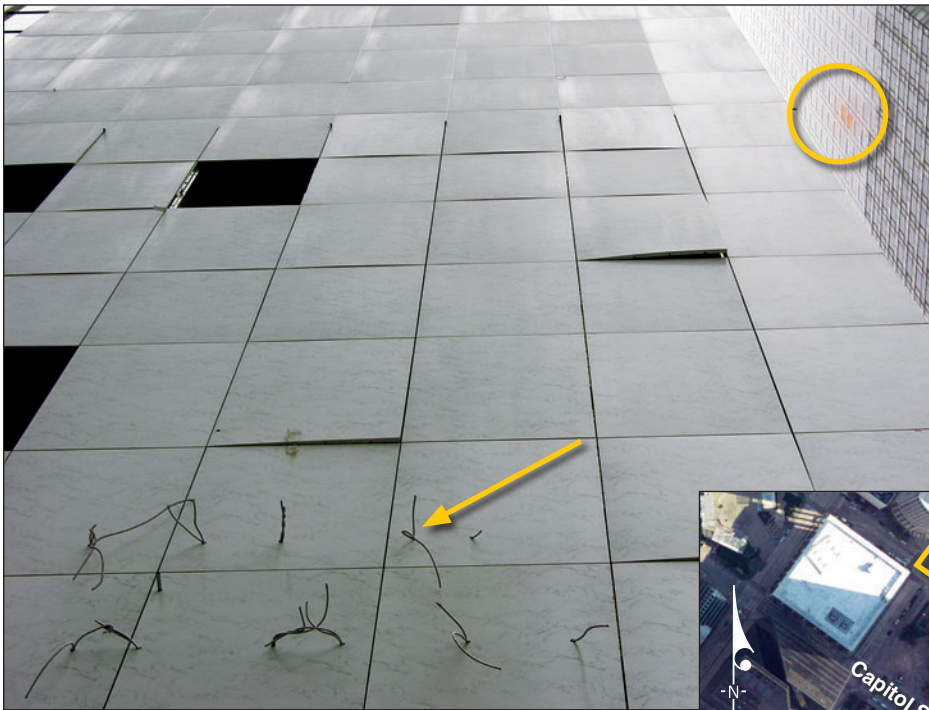
Figure 5-15 shows a building that lost several metal wall panels and a wall-mounted sign; the inset shows the building location and the façade that lost the panels (blue lines). It appears that the wall panel debris had the potential to strike either the JP Morgan Tower or Center.

Figure 5-15.  
Several metal panels blew off of two façades of this building, along with a wall-mounted sign (yellow arrow). Two broken windows can be seen in the yellow circle at the JP Morgan Chase Tower. Inset shows location of building (yellow box); blue lines indicate façades where metal panels blew off.

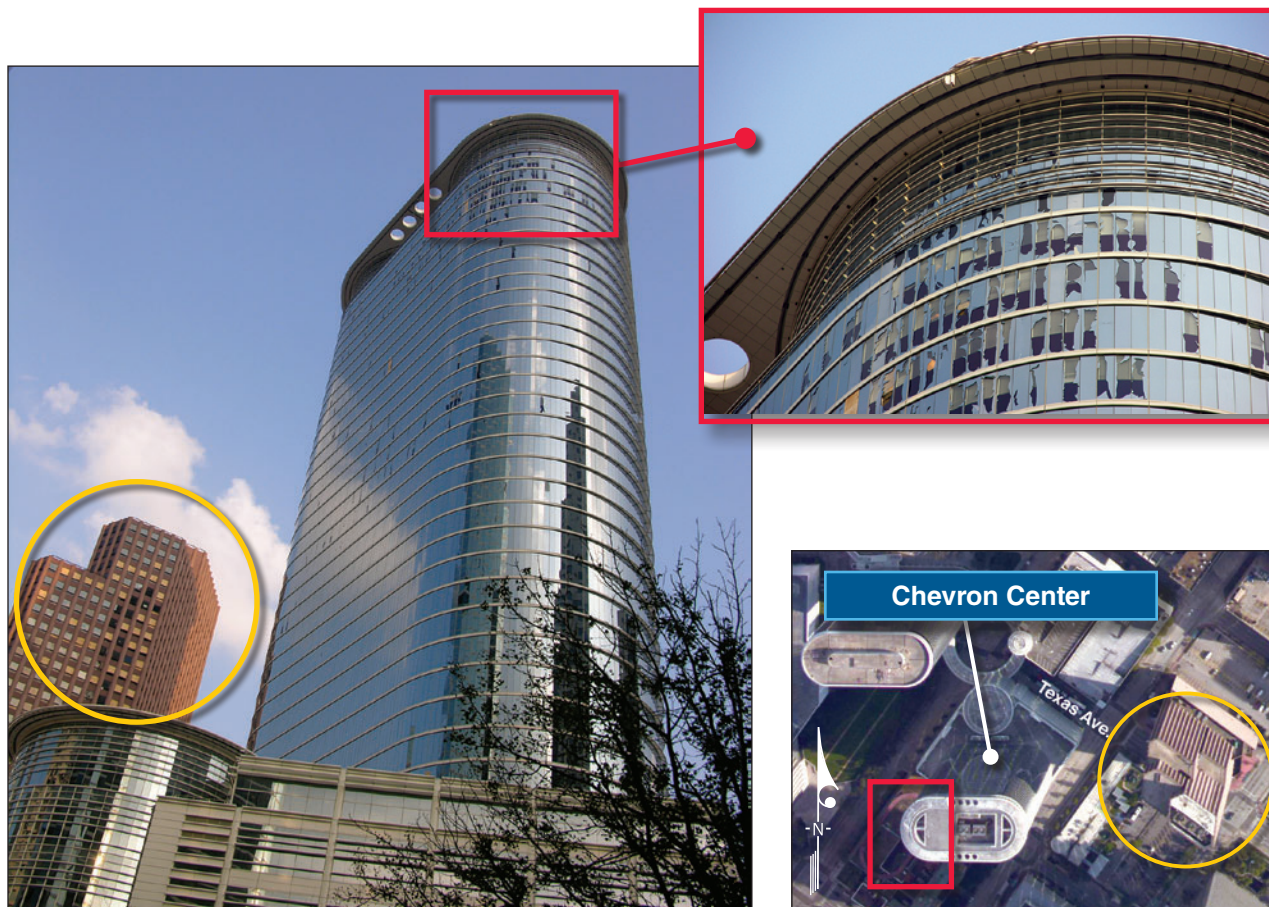
The area of the Chevron Center that received most of the glazing damage is shown in Figure 5-17. The outer panes of about 700 heat-strengthened windows were broken. At seven windows, both the inner and outer lites were broken.

Chevron Center glazing damage. At the building beyond (yellow circle), at least 35 windows were boarded up. Bottom inset shows location.

Cause of glazing damage: Prior to and during the MAT helicopter observations, the glazing damage at the Chevron Center had not been detected. Therefore, the high-rise roofs near the Chevron Center were not observed during the flight for potential debris sources. Subsequent analysis of the NOAA high-resolution photographs did not reveal an obvious debris source. Roof debris from the building designated as B-1 in Figure 5-19 (close up view shown in Figure 5-28) appears to have had the potential to strike the center area of the Chevron Center. Although some glazing damage occurred in the center area, the damage was primarily near the end of the Chevron Center. Also, when the wind was blowing in the direction conducive for roof debris from building B-1 to strike the Chevron Center, the wind speed was relatively low. Therefore, roof debris from building B-1 is not believed to be the primary cause of the Chevron Center glazing damage.

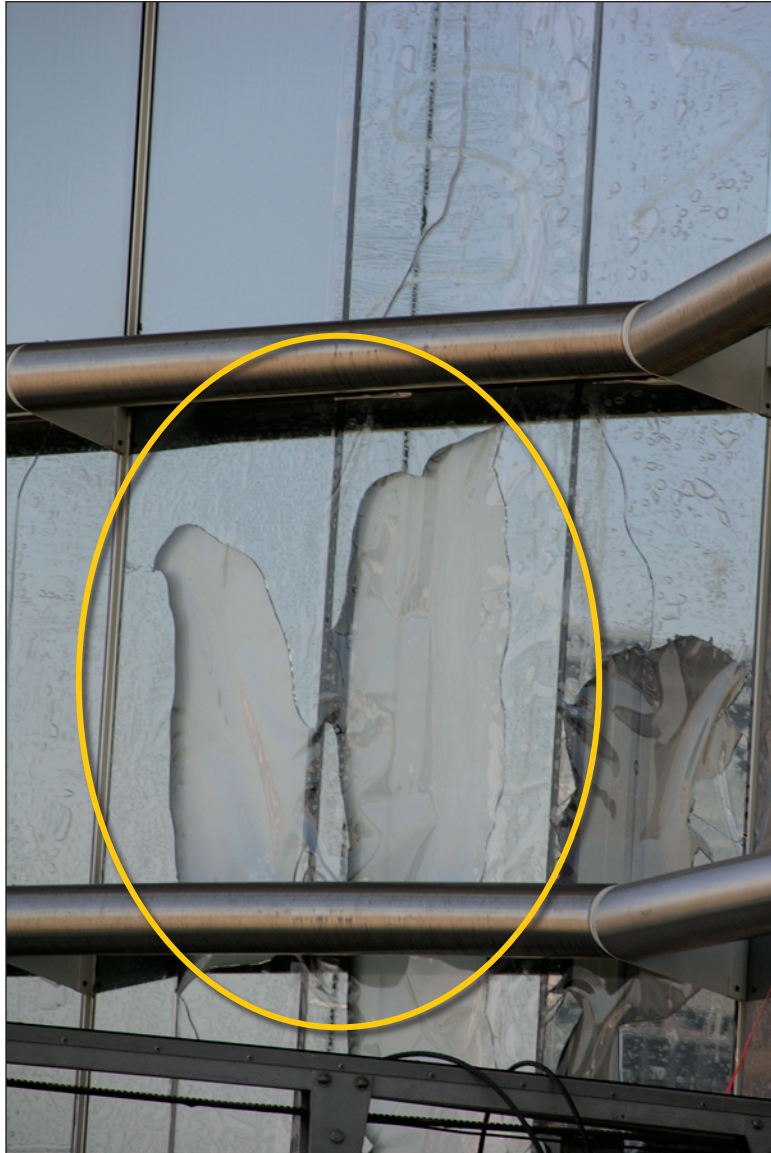
**Figure 5-18.**  
Broken glazing held in place with  
temporary film

Shortly after the storm, the building owner retained a company to quickly install a temporary film over all of the broken glazing as a safety precaution to avoid falling shards of glass (Figure 5-18). Once the protective film was in place, work commenced on removing the broken glass that was still in place. Glass removal took considerable time, hence the initial installation of the protective film was prudent to protect pedestrians.

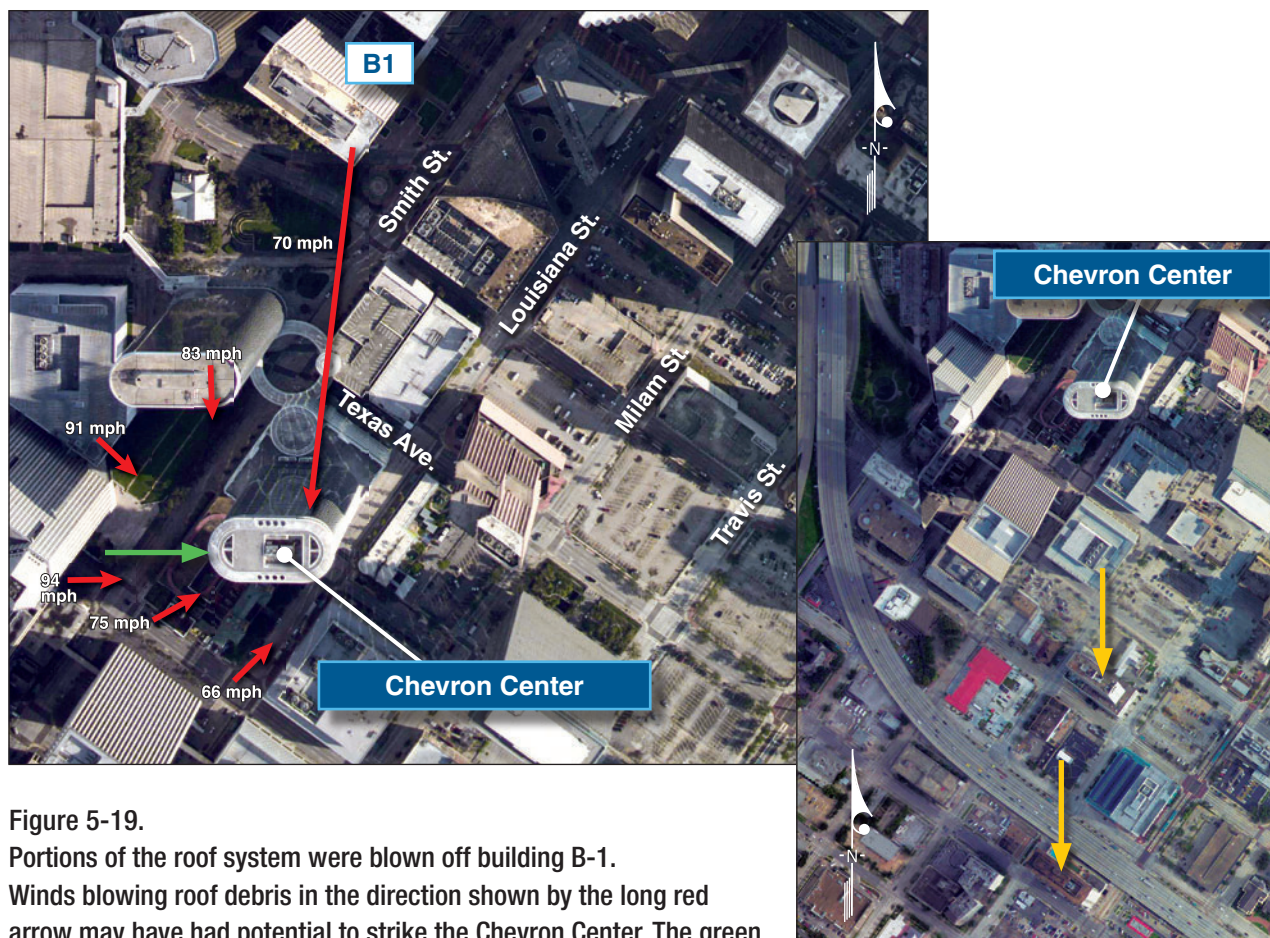
**Figure 5-19.**

Two mid-rise buildings with aggregate-surfaced BURs occur to the south of the Chevron Center (yellow arrows at the inset of Figure 5-19). These buildings are shown in Figure 6-4. The closest building is approximately 250 feet from the Chevron Center, which is well within the flight capability of windborne aggregate. However, wind direction during Hurricane Ike precluded aggregate from these buildings as being potential debris sources for the glazing damage at the Chevron Center (refer to red arrows indicating wind directions shown on Figure 5-19).

Portions of the roof system were blown off building B-1.

Winds blowing roof debris in the direction shown by the long red arrow may have had potential to strike the Chevron Center. The green arrow indicates where a portion of the roof membrane blew off the

Chevron Center. The yellow arrows at the inset show locations of buildings that had aggregate-surfaced roofs.

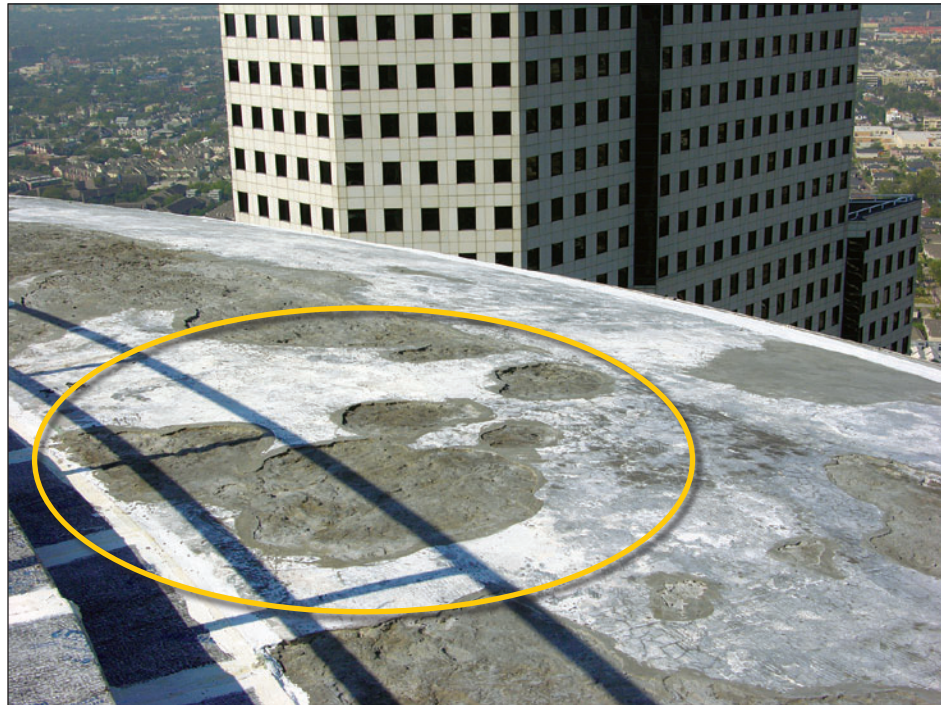
A portion of the PVC roof membrane was blown off in the vicinity shown by the green arrow in Figure 5-19 and as shown in Figure 5-20. The concrete deck was gouged in many locations (Figure 5-20). The gouging may have been due to roof membrane flutter, or it may have been caused by the detached lightning protection conductor.

**Figure 5-20.**  
The lightweight insulating concrete deck was gouged in many locations

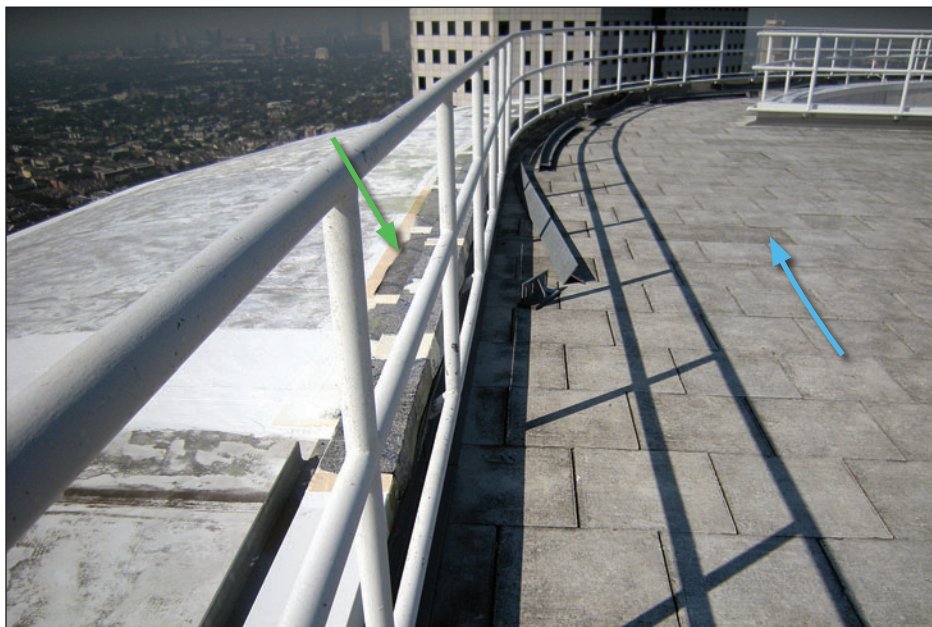
As a result of the roof membrane damage, the window washing track (Figure 5-21) was damaged. Apparently, membrane fluttering caused the nuts on the ½-inch stainless steel bolts to loosen. The galvanized T-shaped window washing track is 4 inches high and 5 ½ inches wide, with a ¼-inch thick head and a ⅜-inch stem.

Figure 5-21.  
View of the damaged  
window washing track  
(green arrow). The  
concrete pavers (blue  
arrow) were not damaged.

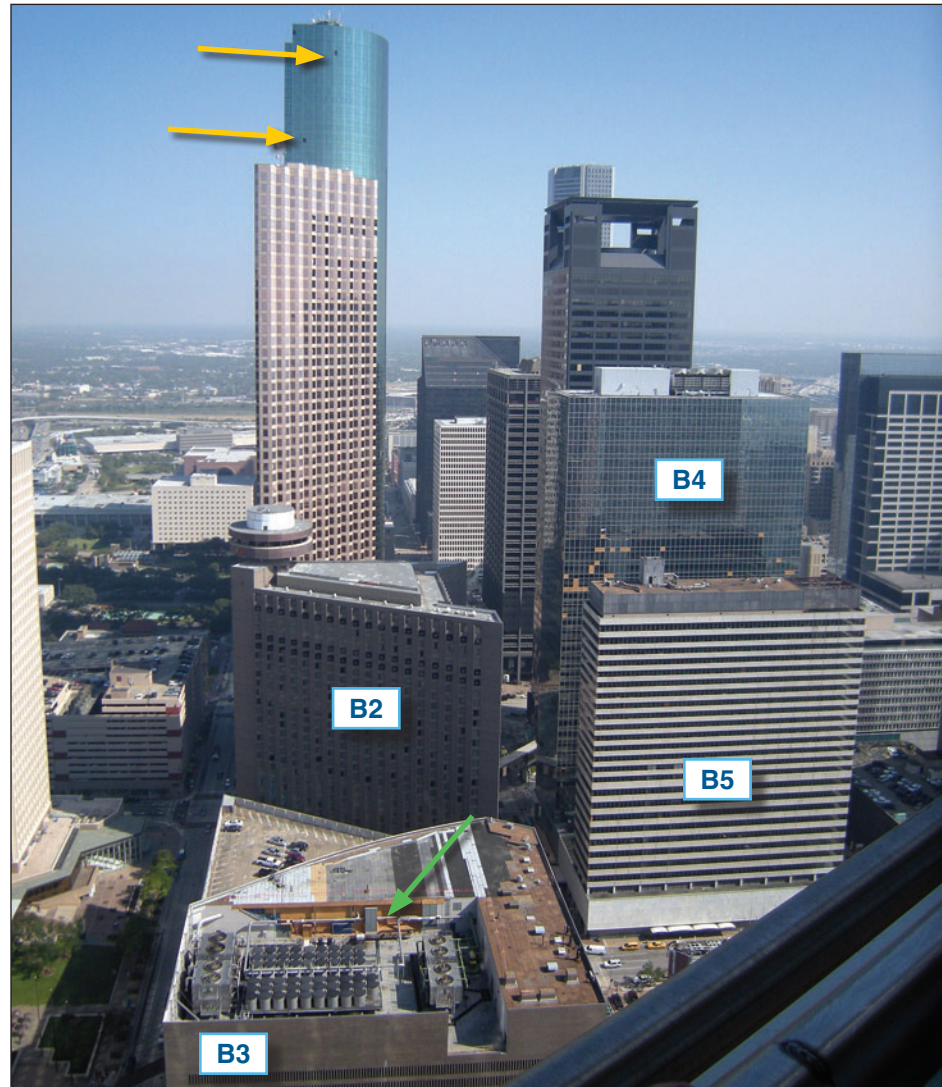
The view in Figure 5-23 is looking northeast from the roof of the Chevron Center. Yellow arrows indicate two broken windows in the high-rise beyond. There was extensive roof covering damage at building B-3, including exterior wall collapse (green arrow).

**Figure 5-23.**  
View of buildings with glazing, roof and wall covering, and rooftop equipment damage

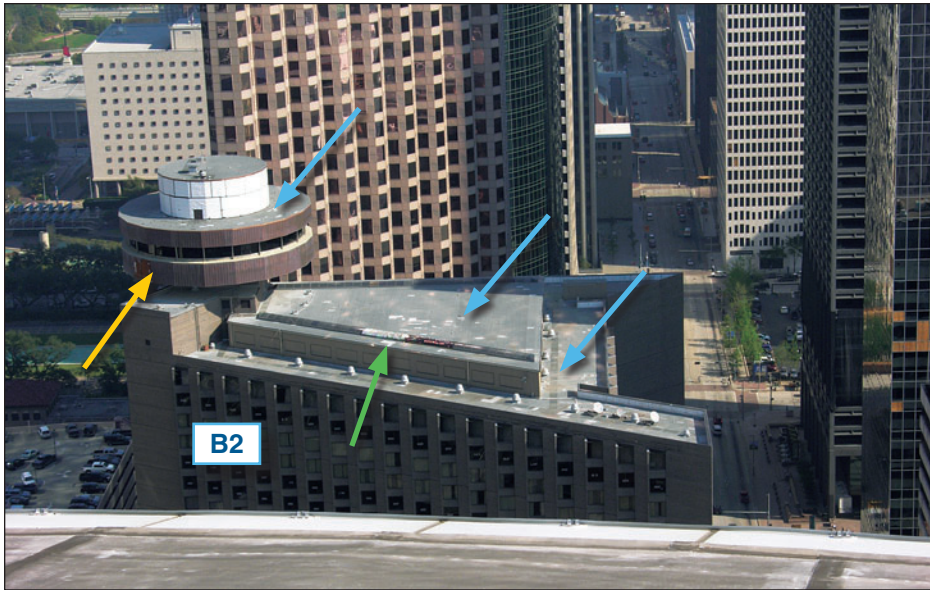
At building B-2, as shown in Figure 5-24, there was roof puncture damage at the three roof areas shown by the blue arrows, metal wall panels were blown off (yellow arrow), skylights were damaged (green arrow), and a fan cowl was blown off the upper round roof. According to a Hurricane Alicia investigator, this building experienced similar damage during that hurricane.

Figure 5-24.  
Roof and wall covering,  
skylight, and roof-top  
equipment damage at  
building B-2

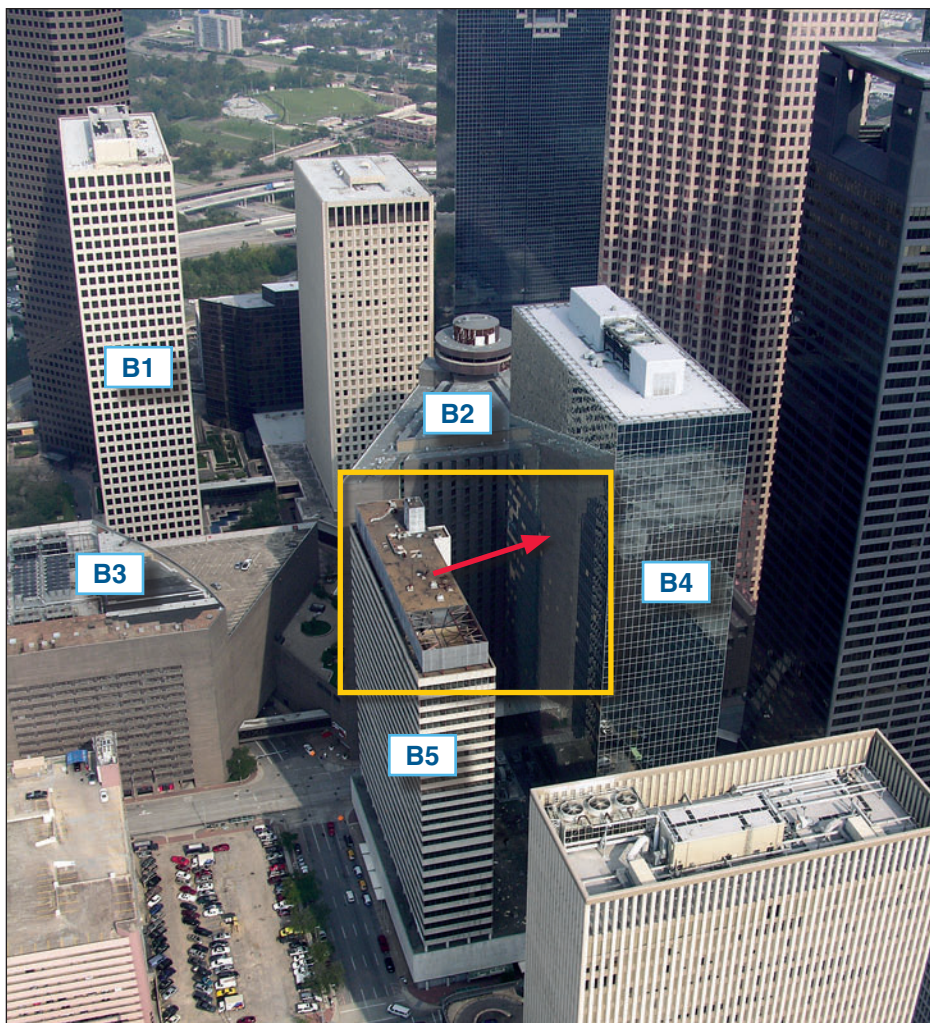
Building B-5 had an aggregate-surfaced BUR with low parapets (likely less than 12 inches high). The aggregate from this roof was a debris source for the building B-4 glass damage (Figure 5-25; close-up shown in Figure 5-26). The red arrow in Figure 5-25 indicates the generalized likely flight path of the aggregate debris. At least two fan cowlings blew off the building B-5 roof. On the back side of building B-5, a few stone veneer panels were damaged (Figure 5-27). According

Figure 5-25.  
Roof aggregate from  
building B-5 was the  
likely cause of the  
majority of the building  
B-4 glass damage. The  
area in the yellow box is  
shown in Figure 5-26.
